CONSTRUCTION ENVIRONMENT, INC.

March 17, 1983

Curbstone

Reference: Examination of a portion of concrete curb kept at the
National Archives, Washington, D. C.

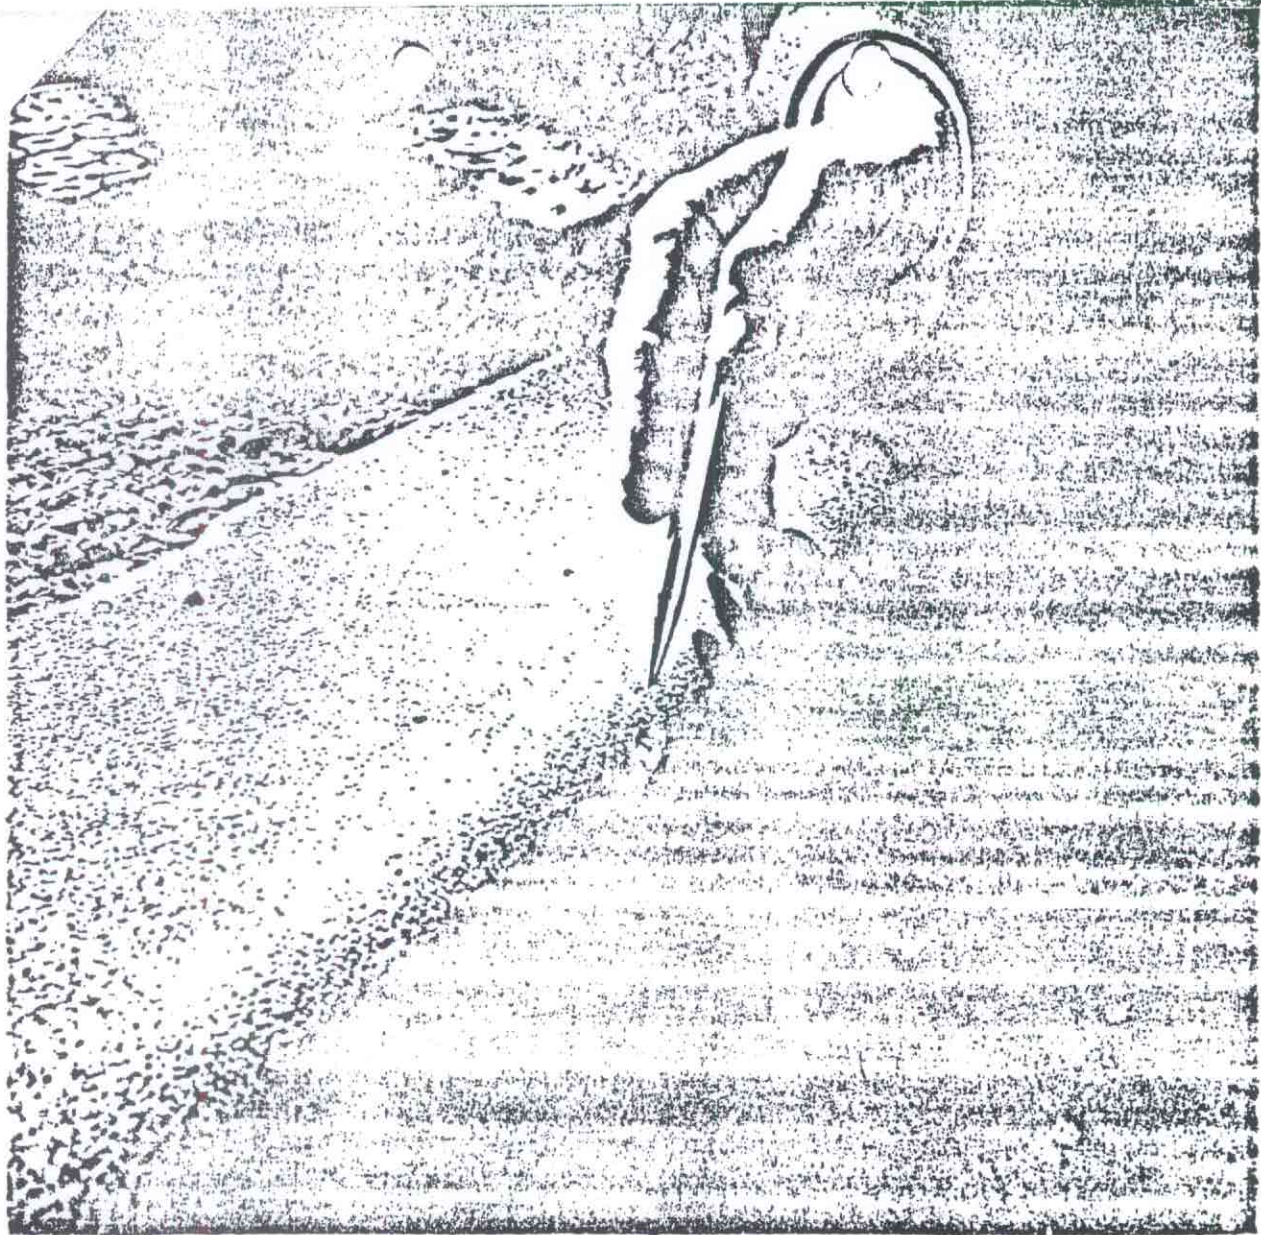
At the center of the concrete curb section, on the vertical face just below the curbed transition between the horizontal and vertical surfaces, there was a dark gray spot. The dark spot had fairly well-defined boundaries, so that it stood out visually from the surrounding concrete surface. The spot was roughly ellipsoidal in shape, approximately 1/2 in. by 3/4 in. in principal dimensions.

The most obvious characteristic of the dark spot was the difference in color. The boundaries of the darker area were as well defined under the 10X magnifier as they were to the unaided eye. It is considered probable that the difference in color is due to the cement paste; however, the possibility of a surface-induced stain cannot be ruled out.

Another difference was noted in the color of the sand grains. The sand grains in the surrounding concrete surface were predominantly semi-translucent light gray in color, but there was also a significant amount of light brown sand grains. The dark spot contained only semi-translucent light gray sand grains. It is possible that the difference in sand color may be due to a different kind of concrete; i.e., a patch, existing in the dark spot area. However, given the ratio of light gray sand grains to light brown sand grains in the surrounding concrete surface, and the relatively small size of the dark spot area, it is also possible that the difference in color of sand grains may be explained in terms of the statistical variations in the distribution of sand grains throughout the concrete mass.

The upper edge of the dark spot appeared to show marks of some sand grains having been dislodged along the boundary between the dark spot and the surrounding concrete area. This is consistent with the relatively weaker zones that normally occur in the thin, or "feathered", edges of a surface patch. Again, however, the dislodgement of sand grains could be due to other causes.

In summary, the dark spot shows visual characteristics which are significantly different from those of the surrounding concrete surface. While any one of the differences, by itself, could be easily explained in terms other than a patch, the simultaneous occurrence of those differences would amount to a rather curious coincidence of characteristics. But the existence of a surface patch would also be consistent with and explain all of the observed differences.

While the results of this visual examination must necessarily be considered inconclusive, it would certainly appear that further investigation is warranted. Since the methods of investigation must be strictly non-destructive in nature, it is recommended that a more detailed visual examination, using techniques of microscopic petrography, be conducted to gain more conclusive information regarding the cement paste, the sand grains and the surface coloration.
